Report No.: AJFTS25006286R01 Date: Apr 28,2025 Page 1 of 27

Sample Description : STEEL MAPERIAL FIREPROOF DOOR

**Test Required** EN 1634-1:2014+A1:2018 Fire resistance and smoke control tests for door and

**Test Report**

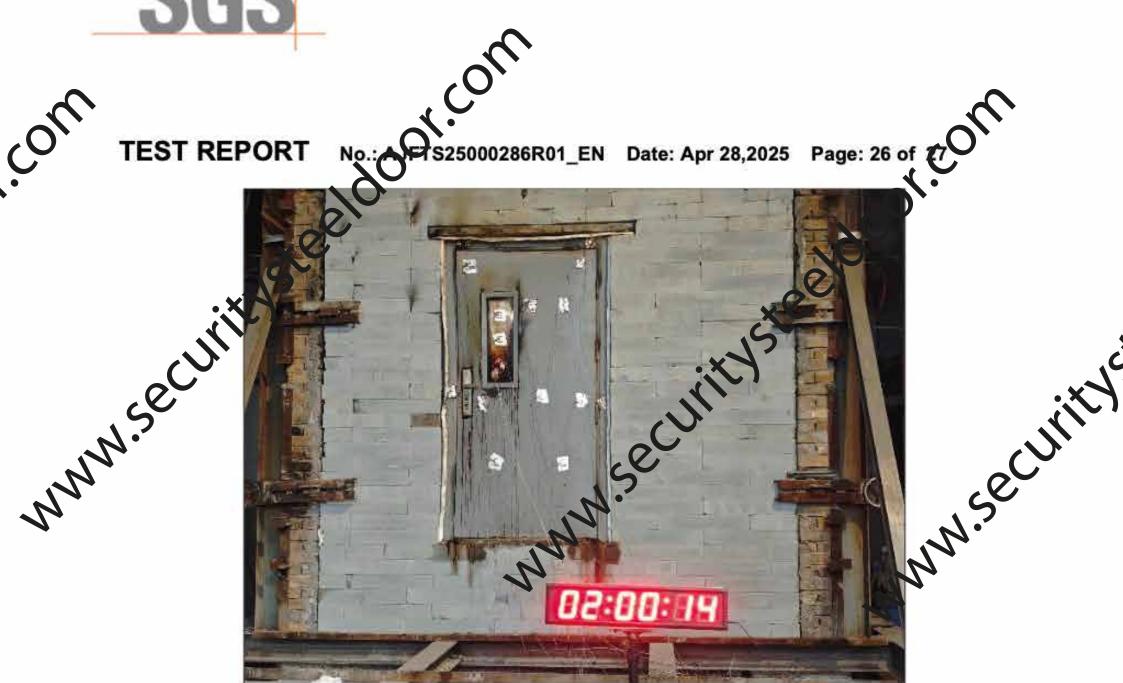
Unexposed face of the specimen (After test duration of 120min)

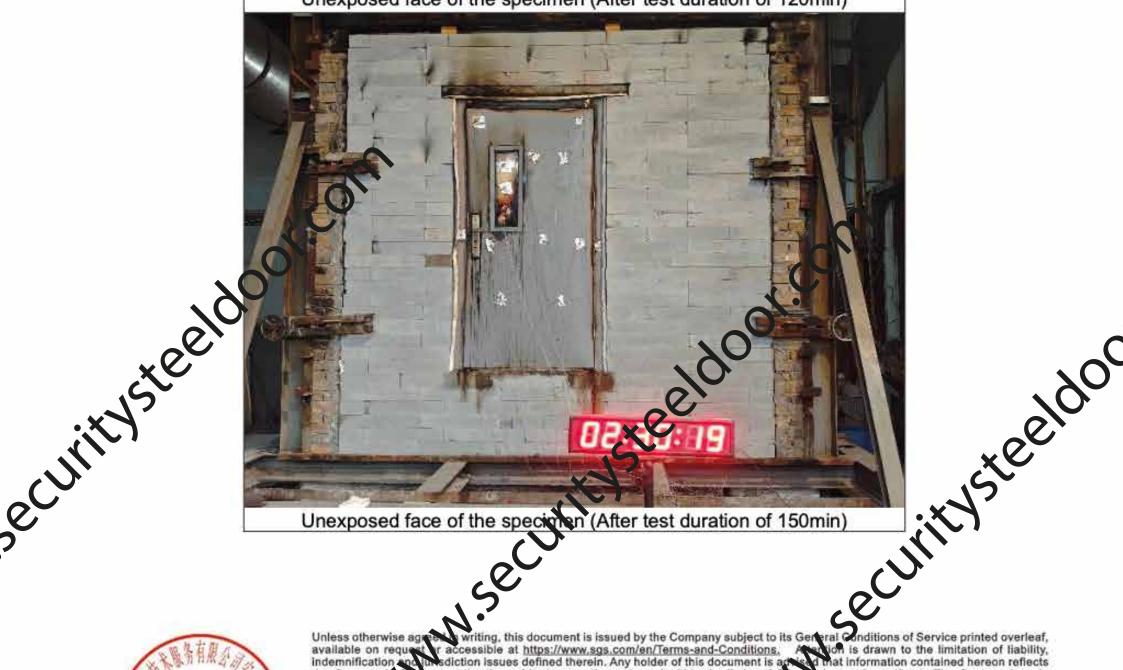
Unexposed face of the specimen (After test duration of 150min)
